The goal of the Feasibility Study is to develop options and recommendations for the renovation and/or reconstruction of the Memorial Park Building and associated grounds including the parking lot. The town is looking for a cost-effective design that provides a long-term solution for the continued and improved use and access of the Memorial Park Building and associated grounds.

The study began with exploration of the Existing Conditions and Programming. Existing conditions includes survey and measurement of the building as well as review of the quality and condition of the construction

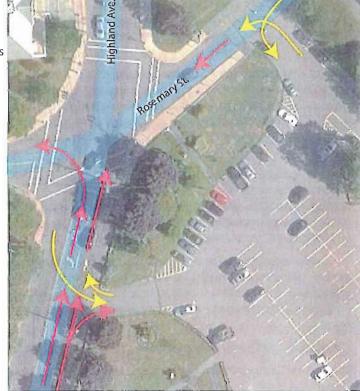
The Highland Avenue access is reported as an 'accident location'. Substantial improvements to access are not achievable through internal site layout modifications and would require complimentary modifications to the

adjacent road design and traffic patterns. Safety can be improved if the Highland access were restricted to one-way (access only) requiring all cars to exit the site via Rosemary. Also, consider prohibiting southbound left turn access to the site from Highland. Eliminating the southbound left turn will reduce the potential for accidents but may also have broader impacts because of redirecting traffic flow for access to the site.

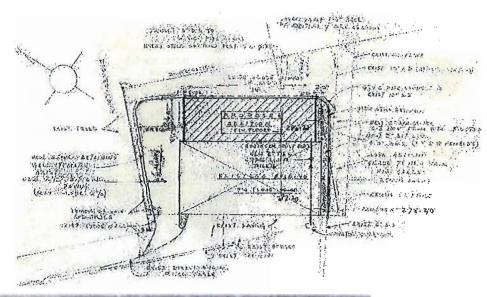
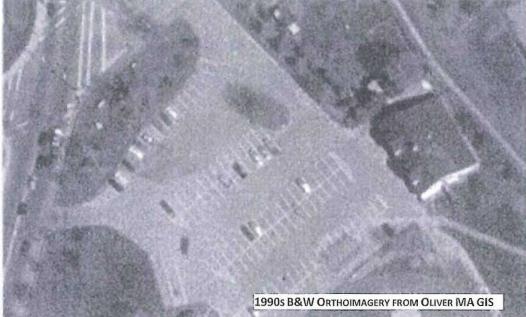
The current field house building is the result of a series of expansions. Drawings prepared by Architect Jay S. Tracy Jr. and

dated August of 1984 depict the building essentially the same as it current form but did not describe second floor uses nor provide windows or stair access to an upper level. It did call for precast concrete deck at the level of what is not the second floor, perhaps in anticipation of future use with occupancy on the second floor. By the 1990s, the upper floor was occupied as evidenced by the dormers and egress stair to the

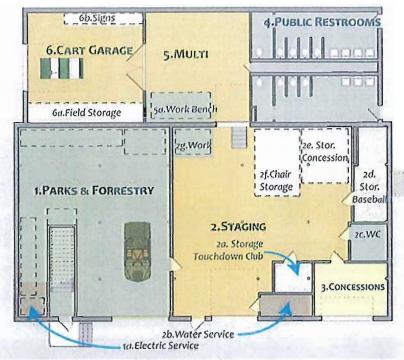
1 FIRST FLOOR - EXISTING CONDITIONS AND USES

Space is also allocated for storage of non-P&F gear including a large tent used for events. The electrical service is in one corner and the main stair divides the space and has storage beneath it.

- 2. Staging labeled for its use during special events and sports equipment distribution. Daily used as a work area, meeting room, lounge and circulation space, providing access to the smaller spaces that surround it. 2f. Chair Storage and 2e. Concession Storage are not secured storage but rather footprint allocations as labeled. Staging also serves as a gathering area (referred to as locker room) for the home football team during half-time.
- 3. Concession is small serving room located at the corner closest to the fields and houses food service equipment, features a rolldown serving window. Includes irrigation controls.
- 4. Public Restroom open to the exterior to support park activities.
- 5.Multi-use -currently arranged as a work area for P&F but is reportedly used for ad-hoc purposes according to need.

Exis	sting Building Areas		Carried Breat Control	8,000
	Space	Area (SF)	Space	Area (SF)
100	First Floor Total	4,700	Second Floor Total	3,300
1.	Parks & Forestry Gar.	1,120	1. Trustees Board Rm.	500
1a.	Electrical Service	50	2. Multi-Purpose	880
2	Staging	990	3. Storage (combined)	1,130
2a.	Storage - Touchdown Club	50	4. Veterans Storage	130
2b.	Water Service	50	5. Kitchen	100
2c.	Restroom	60	6. Restrooms	100
2d.	Storage-Baseball / Softball	140	7. Mechanical Utility	100
2e.	Concession Storage	140	Corridor	380
2g.	Chair Storage	150	Please note: areas reported	
2g.	Work Area	60	approximate and rounded t	
3.	Concession Stand	180	nearest 10 for individual sp 100 for totals	aces and
4.	Public Restrooms	590	100 jui tutais	
5.	Multi Use Garage	430		
5a.	Work Bench	90		
6	Cart Garage	430		
6a.	Storage-Field Equip.	100

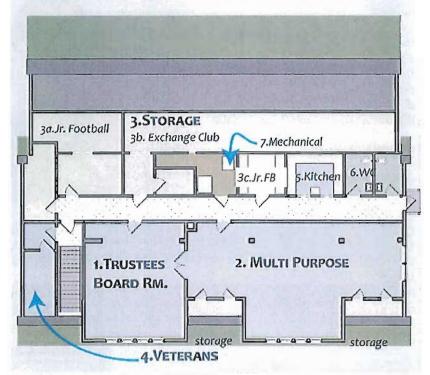
1 SECOND FLOOR - EXISTING CONDITINOS AND USES

3. Storage – across the corridor are several smaller spaces, that extend under sloping rafters that are used for storage by related organization.

- 4. Veterans a small area, referred to as office space, this room to the left of the stair, contains a variety of stored items and includes office records.
- Kitchen a u-shaped kitchen with appliances, the kitchen is currently being used for storage.
- 6. Restrooms- one male and one female individual rooms.
- 7. Mechanical Equipment

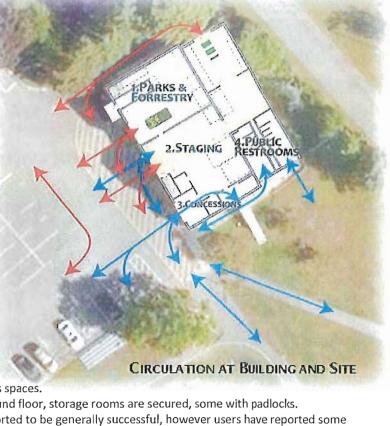
### Use Scenario - Halftime

The plan at right shows the accommodations available to the teams during halftime. The two team's spaces are not suitably enclosed, they both rely on one internal restroom or nearby public restrooms, both are simultaneously open to storage areas and the home team is in close proximity to Concessions activity.

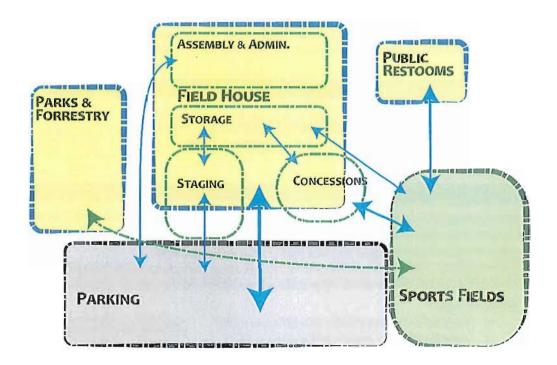
- → Separation of uses, Assembly has most stringent requirement, must be separated form storage and garages.
- → Park and Forestry can, should be self-contained.
- → Optimal location for storage on the ground floor.
- → Middle garage becomes Staging, multi-purpose room.
- → Assembly functions on upper levels

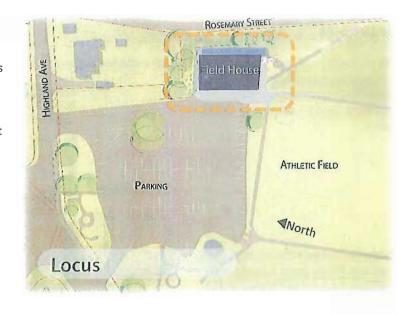
Site Plan

The new larger building sits in approximately the same location as the existing but is shifted to accommodates zoning setback not established at the time the original was constructed.
